**PERFORMANCE EVALUATION OF CARTER ARCHITECTURAL PANELS, INC.  
“CORE CONNECT RAINSCREEN PANEL SYSTEM”  
IN ACCORDANCE WITH AAMA 509-22 & ASTM E330/E330M-14(2021)**

Report No.: 26-06-B0105-2  
9 Pages, 3 Appendix

At the request for Carter Architectural Panels, Inc., Element was retained to evaluate the "CORE CONNECT Rainscreen Panel System" rainscreen systems in accordance with AAMA 509-22 and ASTM E330/E330M-14(2021) as outlined in Proposal Number 26-006-866273 RV1.

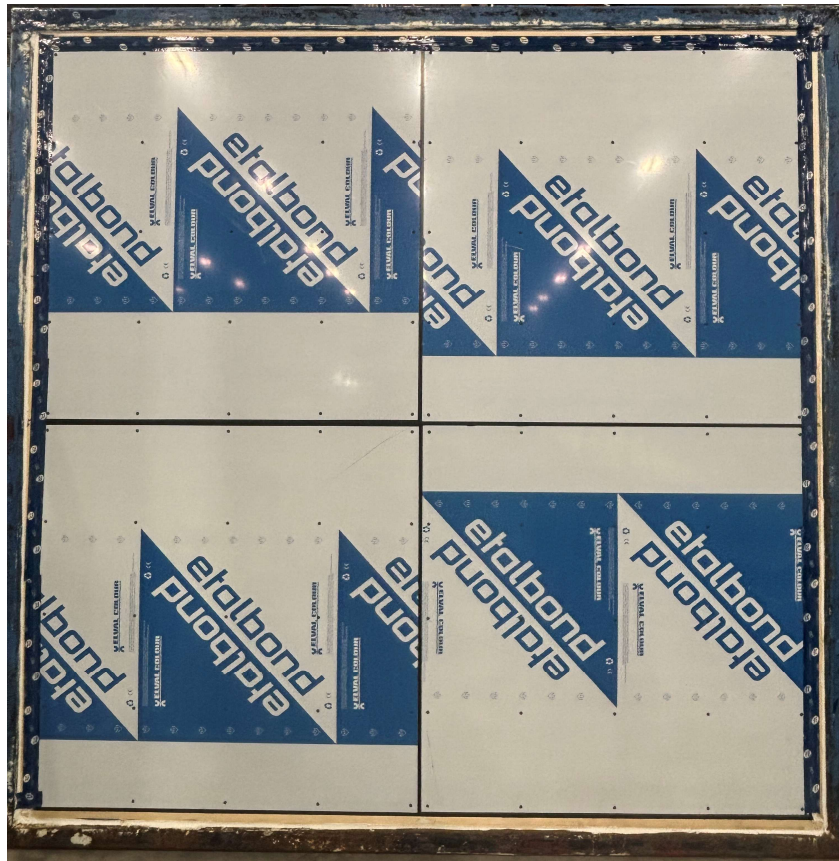
Figure C1 – Test Specimen Post Structural (Exterior View)

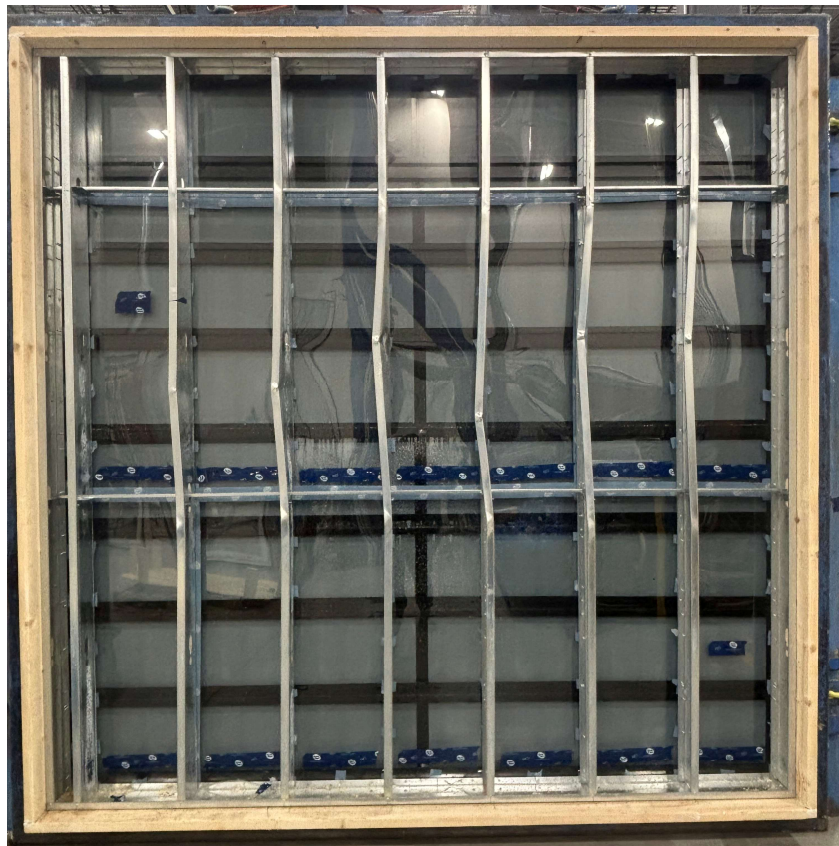
Figure C2 – Test Specimen Post Structural (Interior View)

| <b>Table 7 – Client Specific (Requested) Testing</b><br><b>Test to Failure in the Negative Wind Load Direction ASTM E330-14(21)</b><br><b>Element Specimen Number: 26-06-B0105-2 (Test Date: September 15, 2026))</b> | |
|---|---|
| 6,045 Pa <sup>(3)</sup> | Cladding System did not disengage from wall assembly. However, the vertical supporting steel studs buckled in the center. |
